Facility: AltEn, LLC
 IIS: 84069
 PCS: NE0137634

Facility Site Inspection Report

AltEn LLC - Storm Water Temporary BMP Check Map

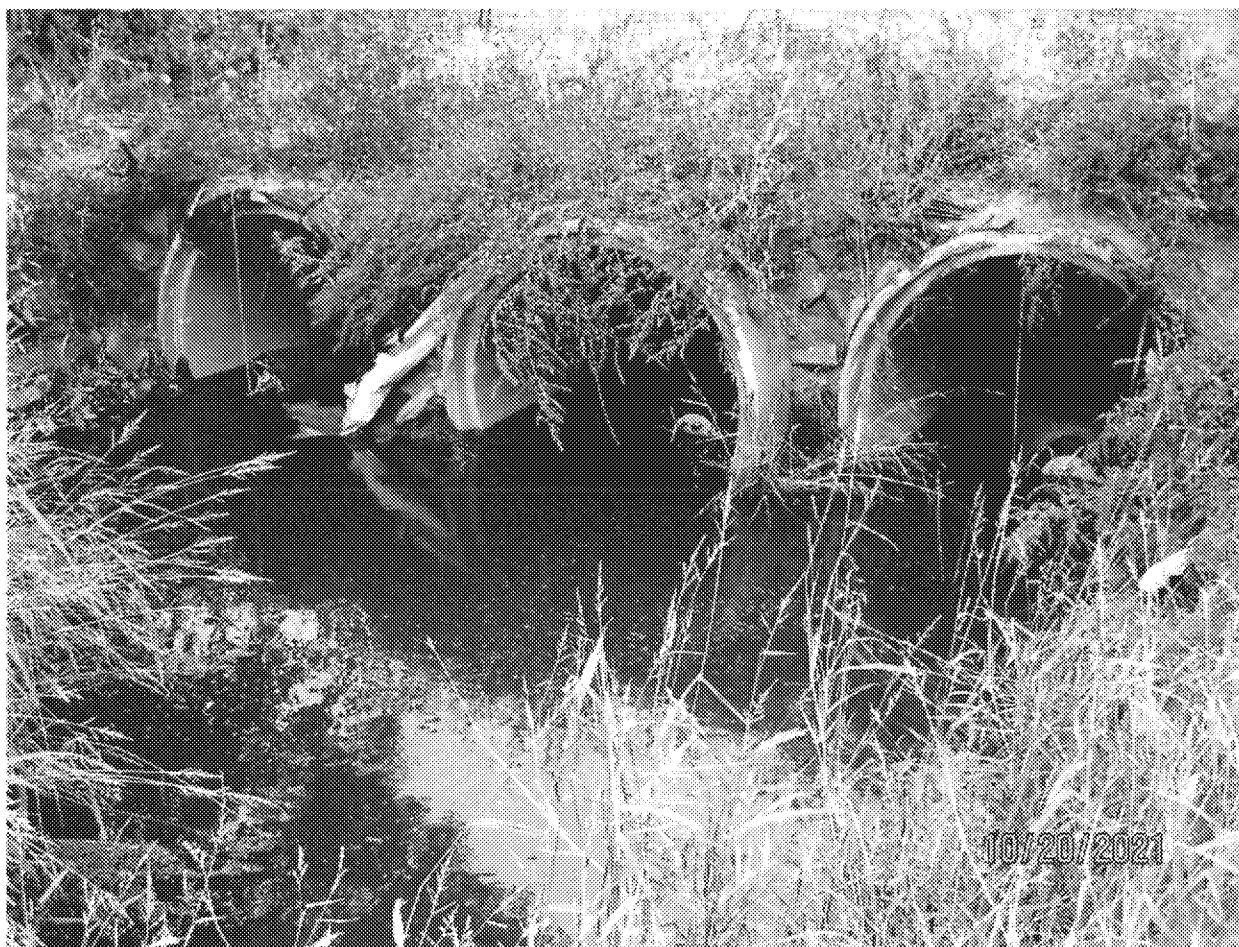
Photos: 1

Location: Culverts north of CR 9 & J

Description: The photo shows the culverts on the west side of CR 9. The emergency inflatable pipe plugs visible in the photo are set in each culvert to be deployed (inflated) in the event of a spill at the AltEn facility. If inflated, the plugs will prevent wastewater from flowing downstream which is part of Clean Harbors Emergency Response Plan. Water is still very cloudy.

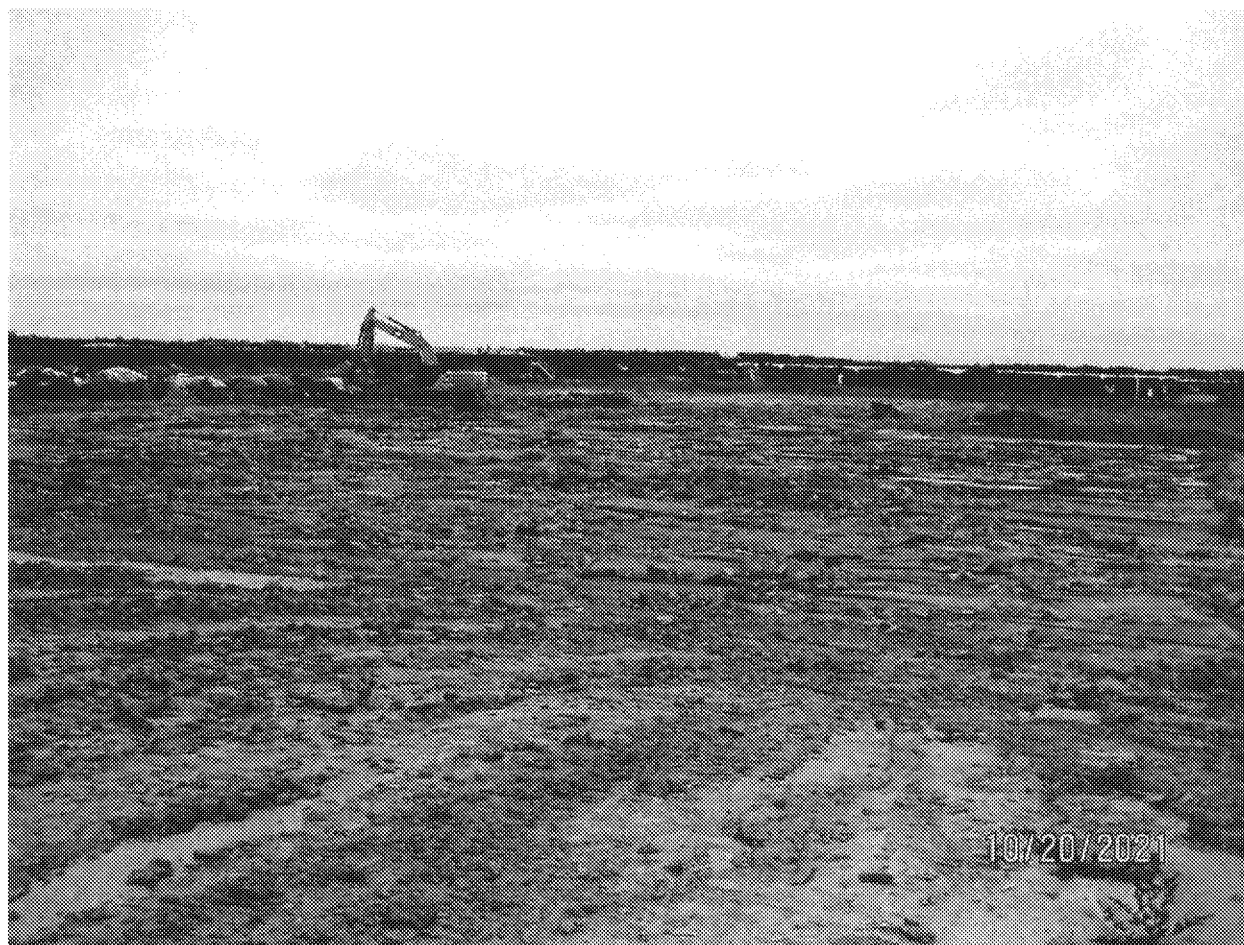
Photos: 2

Location: West side of tank field

Description: Clean Harbors continues to remove soil down to the geomembrane in preparation for the new lagoon. The soil is then being transported to the former east wetcake pile location.

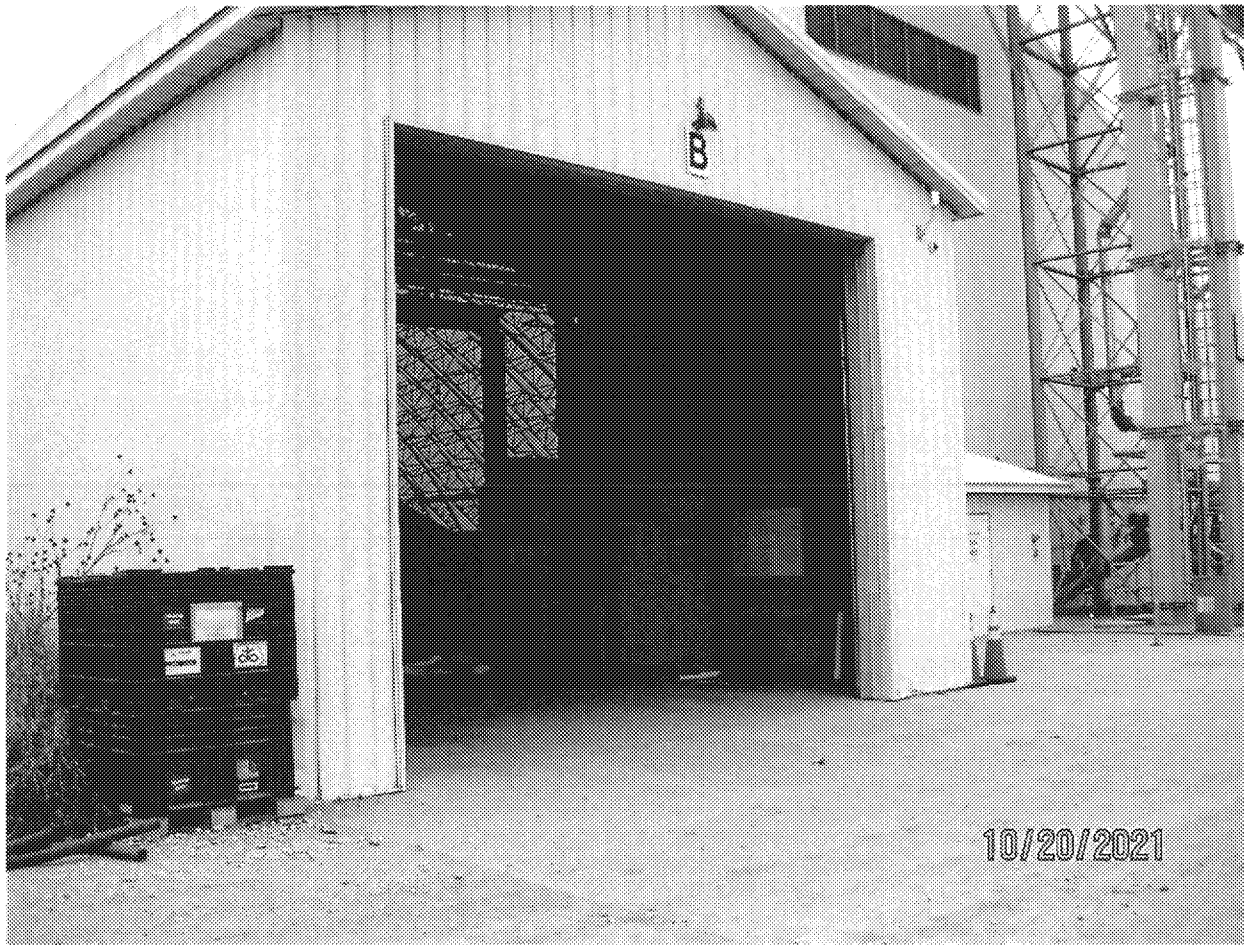
Photos: 3

Location: East side of the south hoop building.

Description: The south hoop building is still not secured from unauthorized entry on both sides and the roof has not yet been repaired.

- Address whistles/tears in northeast lagoon liner.
- Replace stormwater containment surrounding the biochar area.
- Address potential track out of biochar residue during dismantling of equipment.
- Repair and secure south hoop building.
- Continue dust suppression on haul roads.

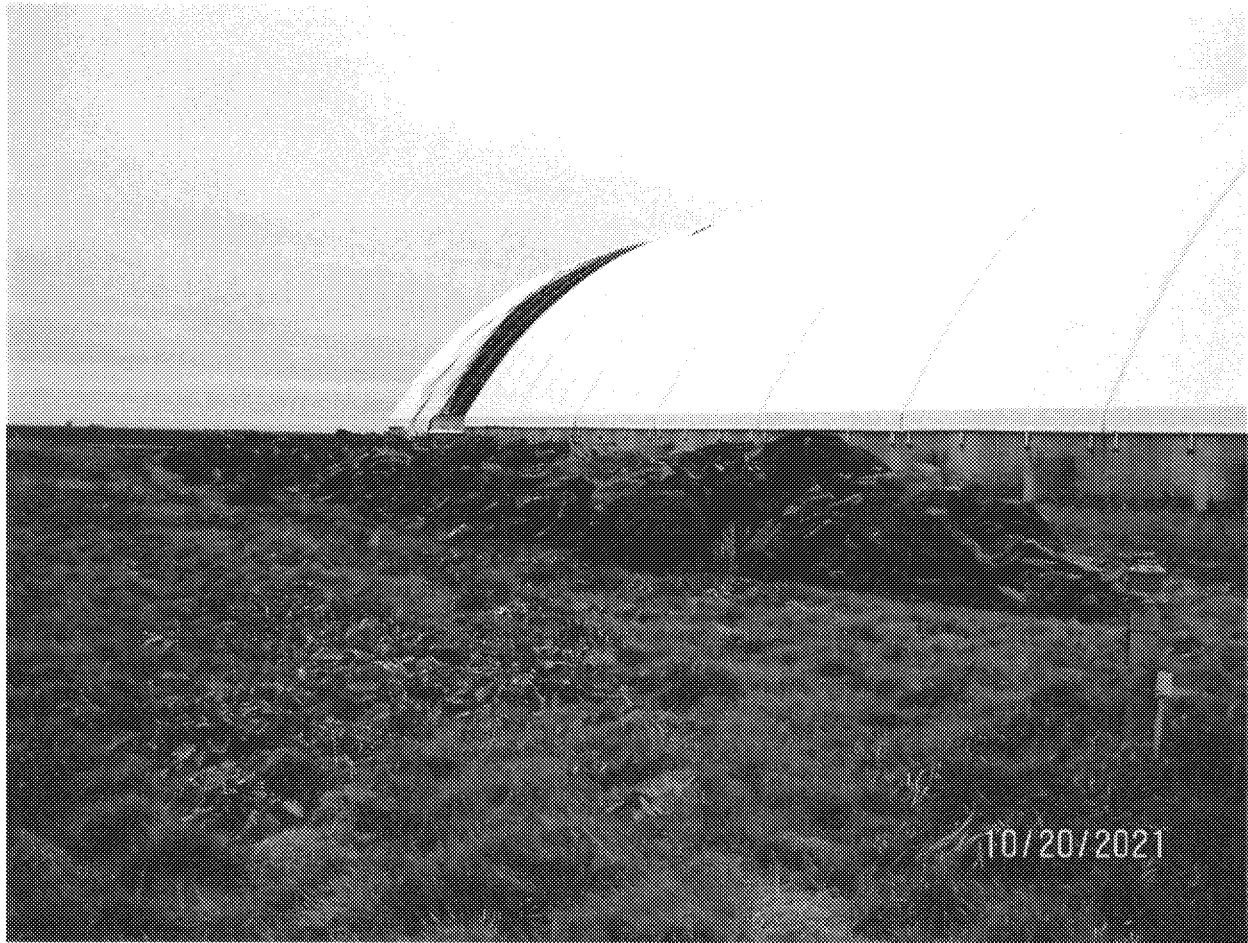
Photos: 4

Location: South side of south hoop building

Description: Clean Harbors is temporarily storing geomembrane removed from the tank field south of the south hoop building. Also, the roof on the south hoop building has not yet been repaired.

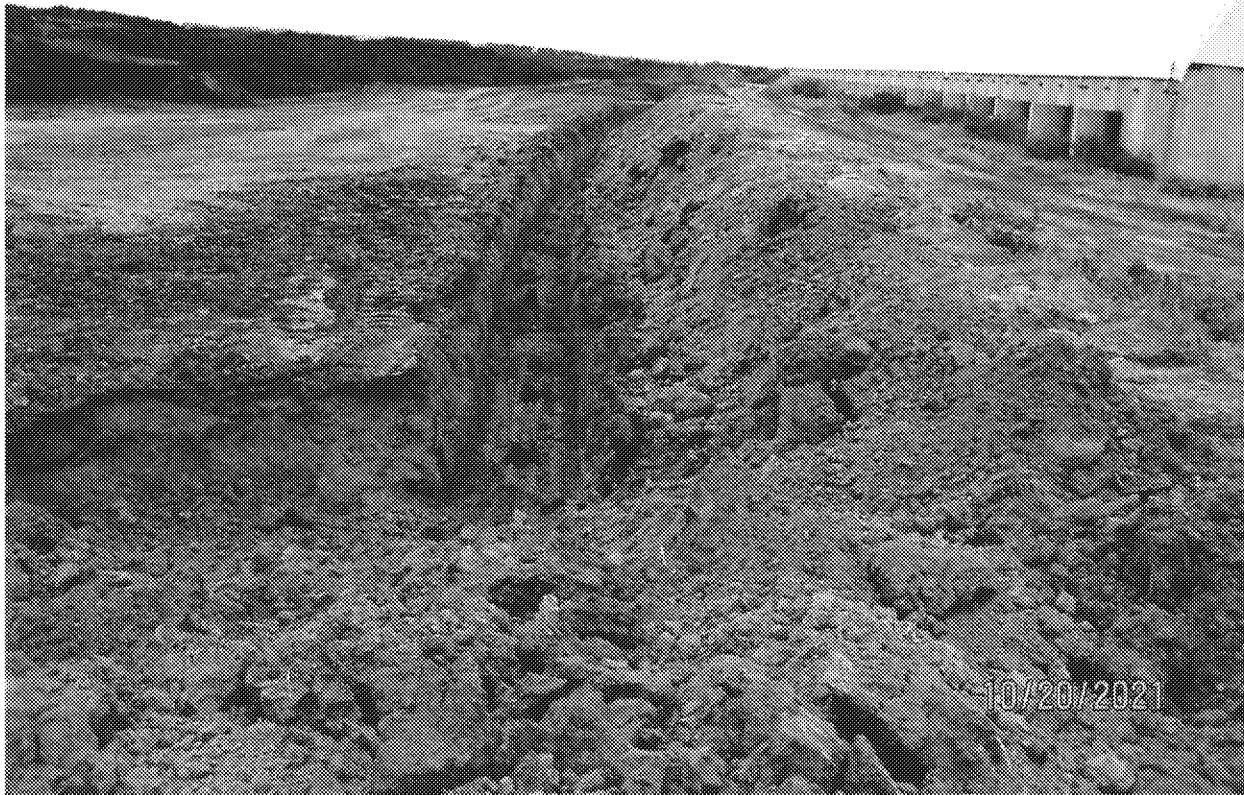
Photos: 5

Location: North side north hoop building/south of northwest wetcake storage area.

Description: The photo the newly erected berm and trench that are closer to the north hoop building.
This was to allow for extra space in the wetcake storage area.

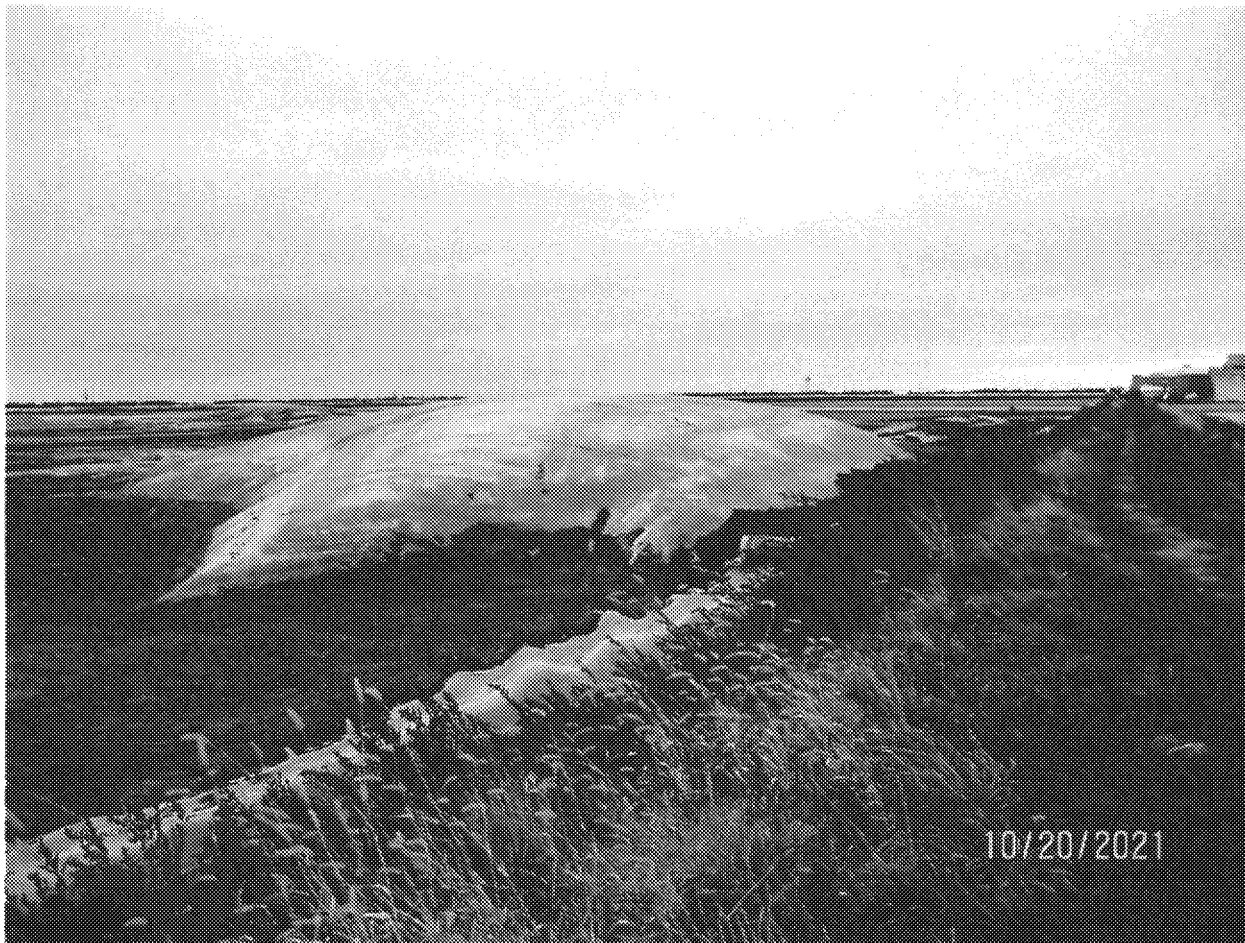
Photos: 6

- Northeast lagoon
 - Large whales present with much of the liner on the surface. The northeast corner of the liner has a section of wastewater collecting in the corner behind the largest whale.
- Northwest lagoon
 - No change in liner condition or lagoon water was observed. 4 whales are present and thick green sludge is accumulating along the west side and northwest corner.
- South lagoon
 - No change in liner condition or lagoon water.

Location: Northwest corner of northeast lagoon

Description: The photo one of the larger whales along the west edge of the northeast lagoon. Much of the liner was exposed or only appeared to be submerged under a few inches of wastewater and sludge.

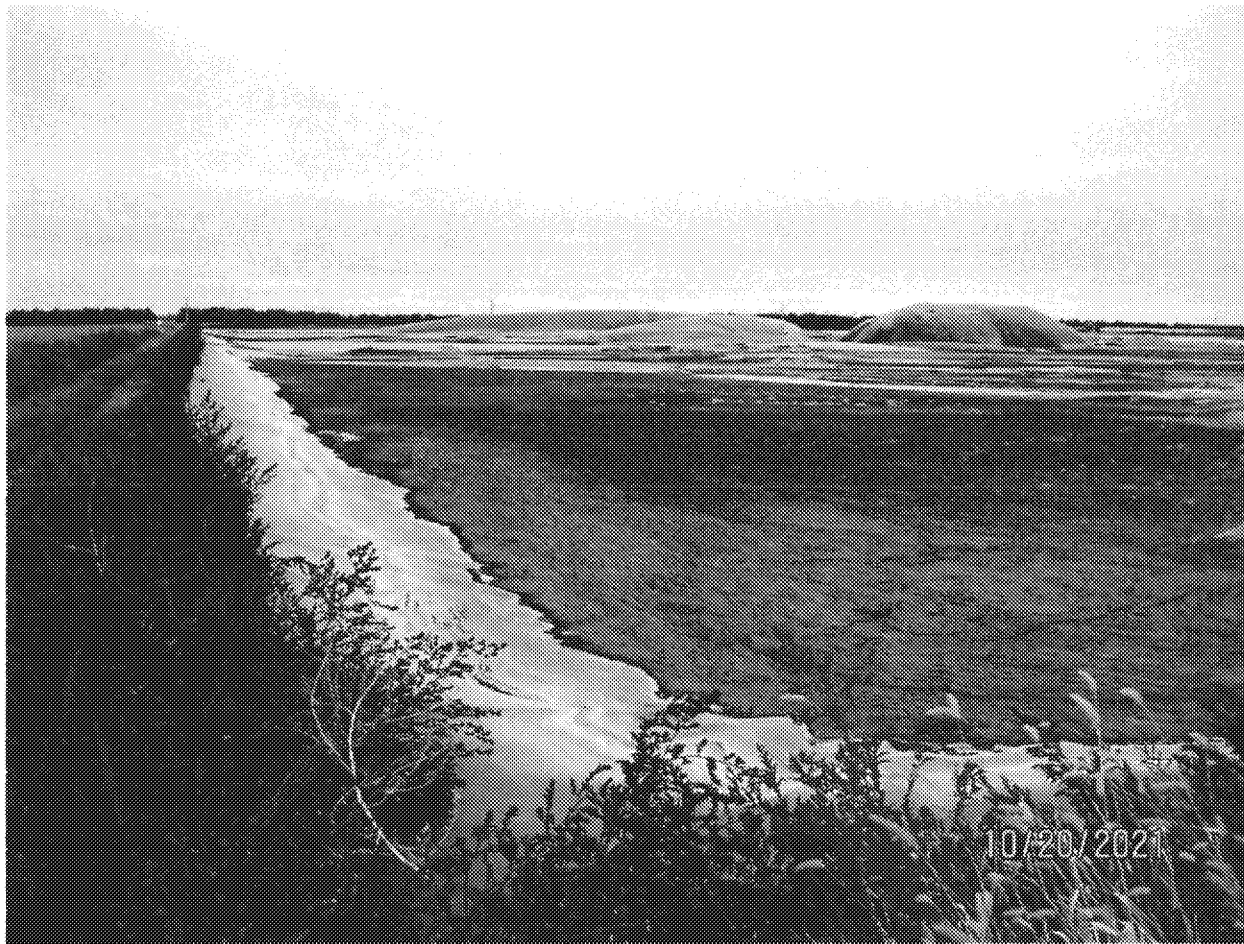
Photos: 7

Location: Northeast corner of northwest lagoon

Description: The photo shows the large whales on the east side of the northeast lagoon. Much of the liner was exposed or only appeared to be submerged under a few inches of wastewater and sludge.

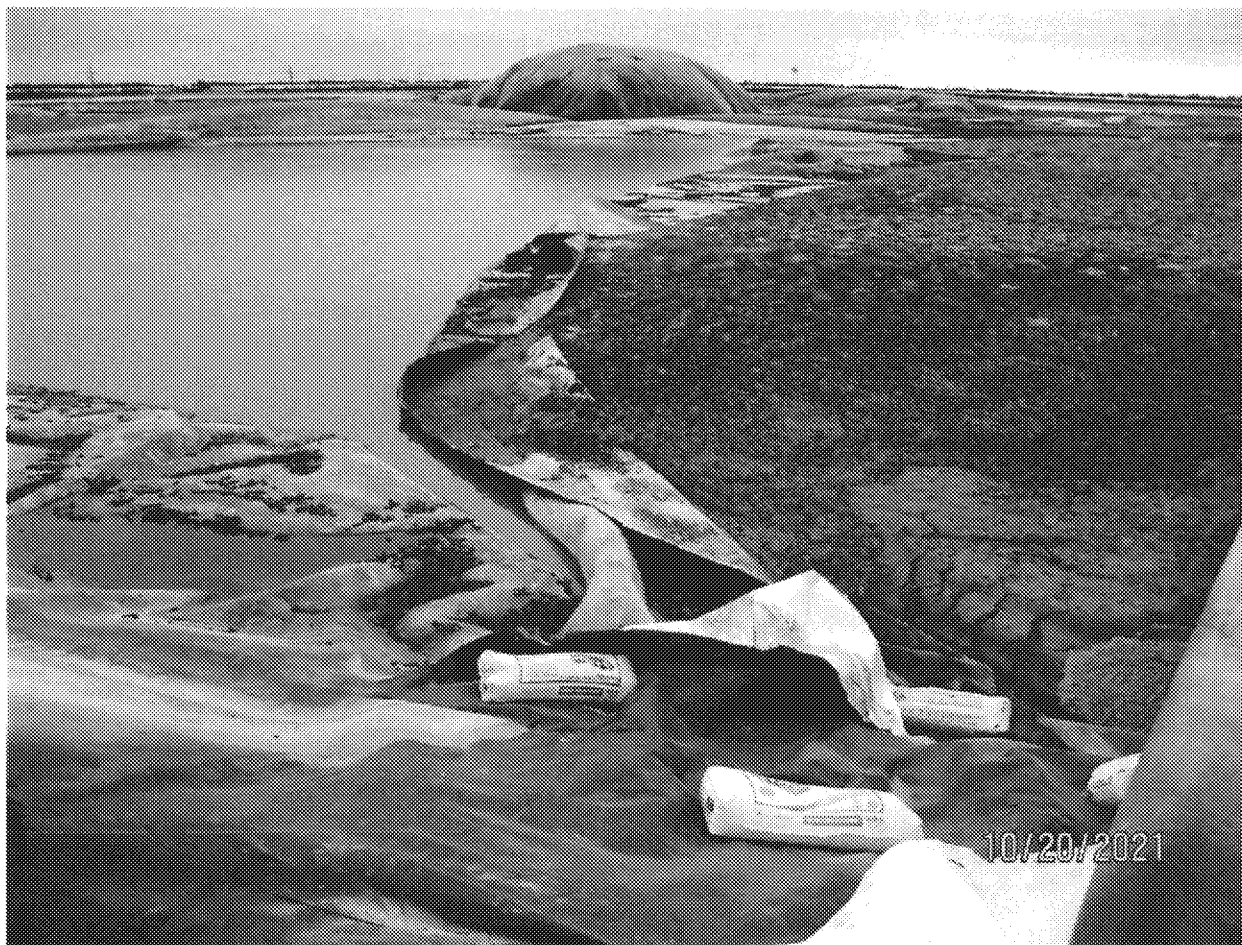
Photos: 8

Location: North bank of northeast lagoon

Description: The photo shows part of the liner edge appears to have become detached. The wastewater appears much deeper to the left of the folded edge and only inches deep with a layer of sludge to the right.

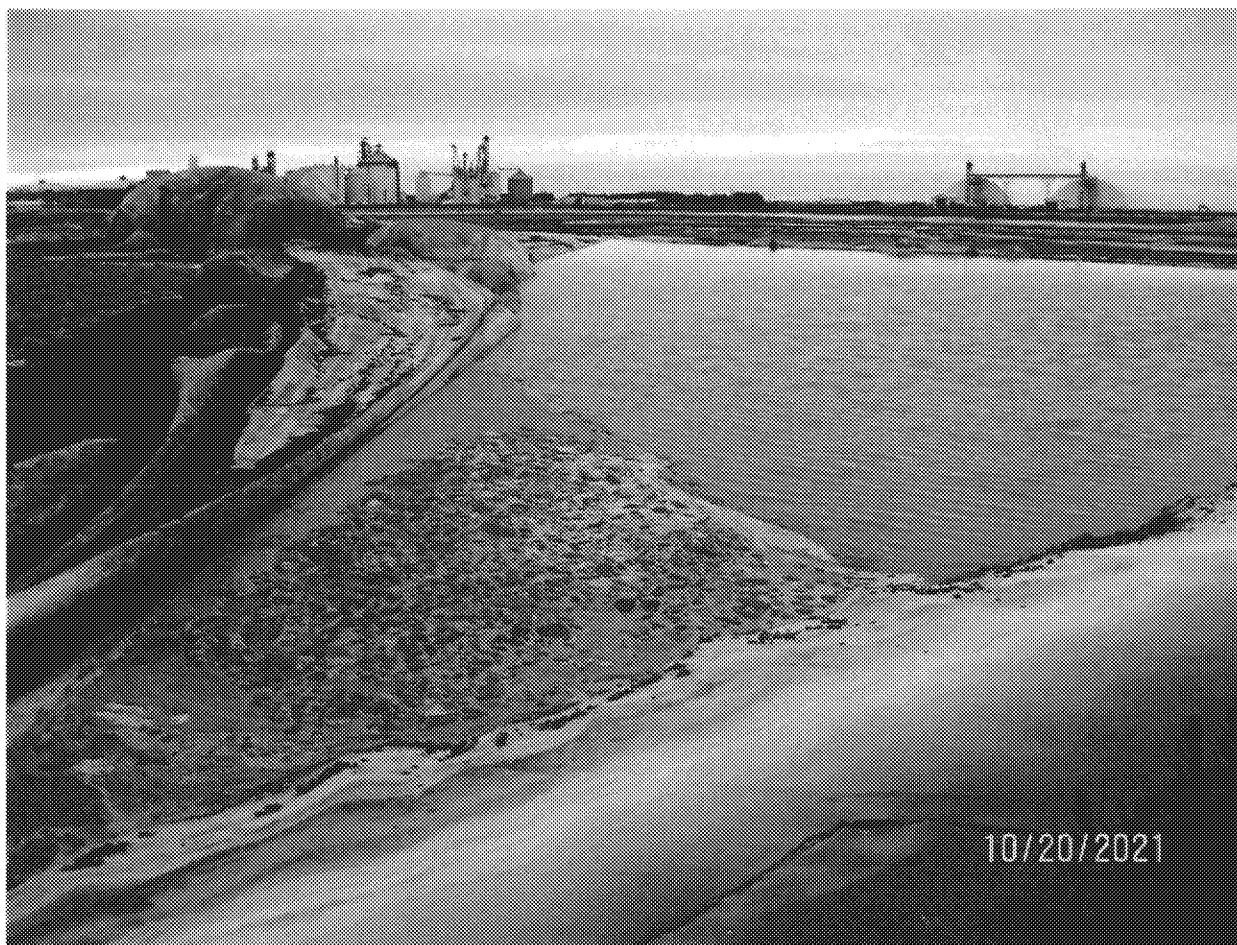
Photos: 9

Location: North edge of northeast lagoon.

Description: The photo shows part of the liner bunched up on the left side with deep wastewater on the right side of the photograph.

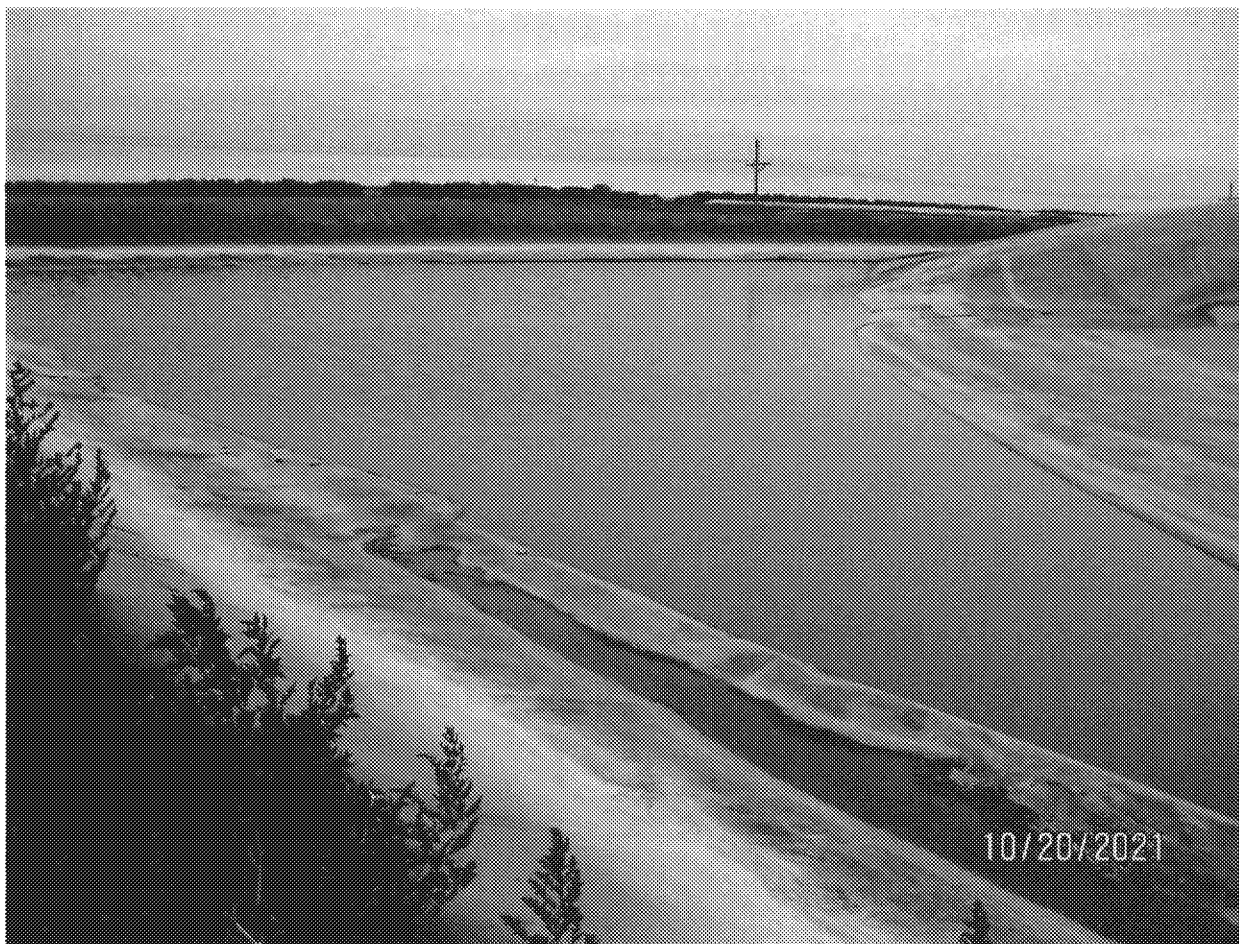
Photos: 10

Location: Northeast corner of the northeast lagoon.

Description: The photo shows a section of wastewater that has been separated from the main body of water by the nearby growing whale.

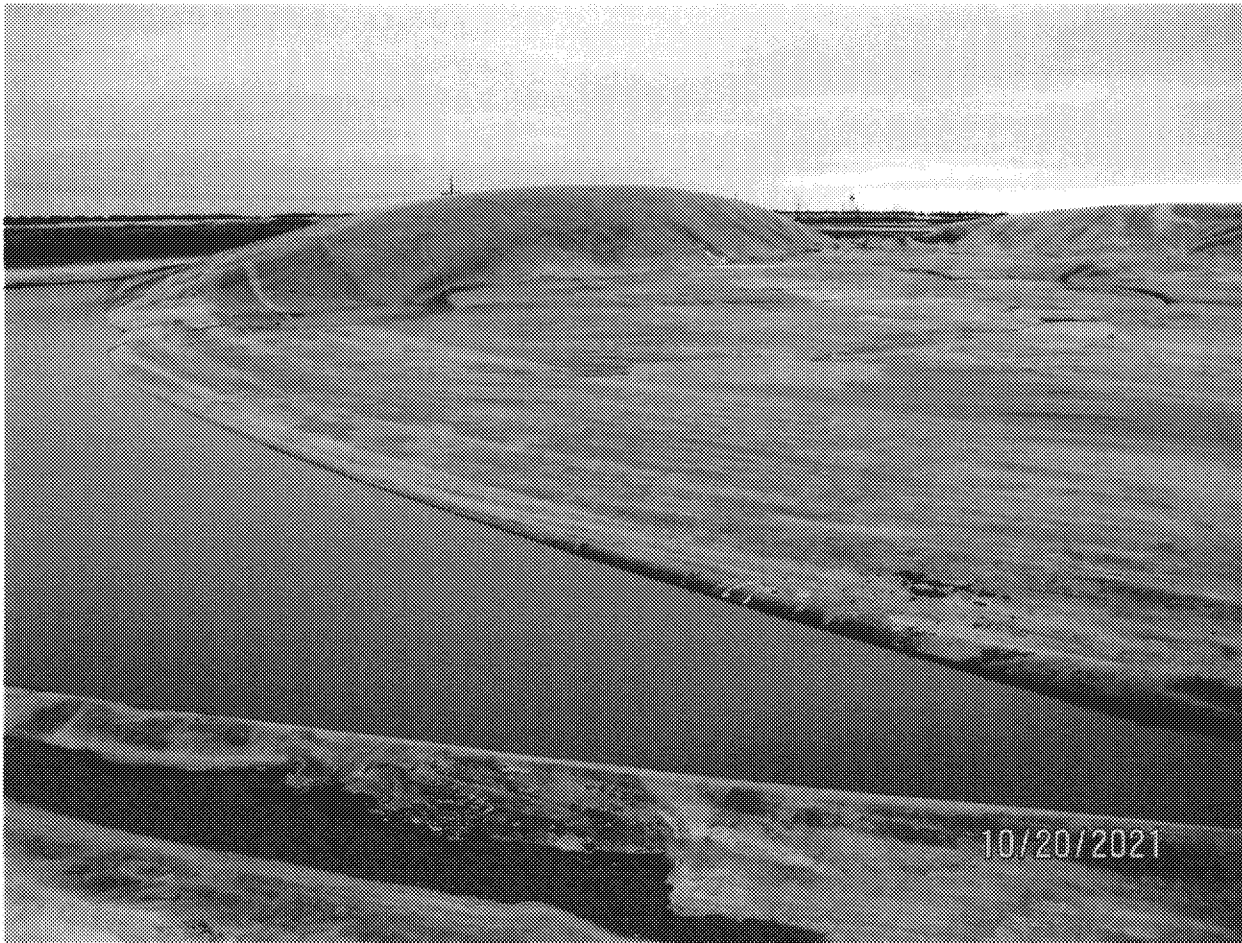
Photos: 11

Location: Northeast corner of northeast lagoon

Description: The photo shows the large whale that has cut off a large area of wastewater from the main body. Much of the liner is exposed and appears to be floating.

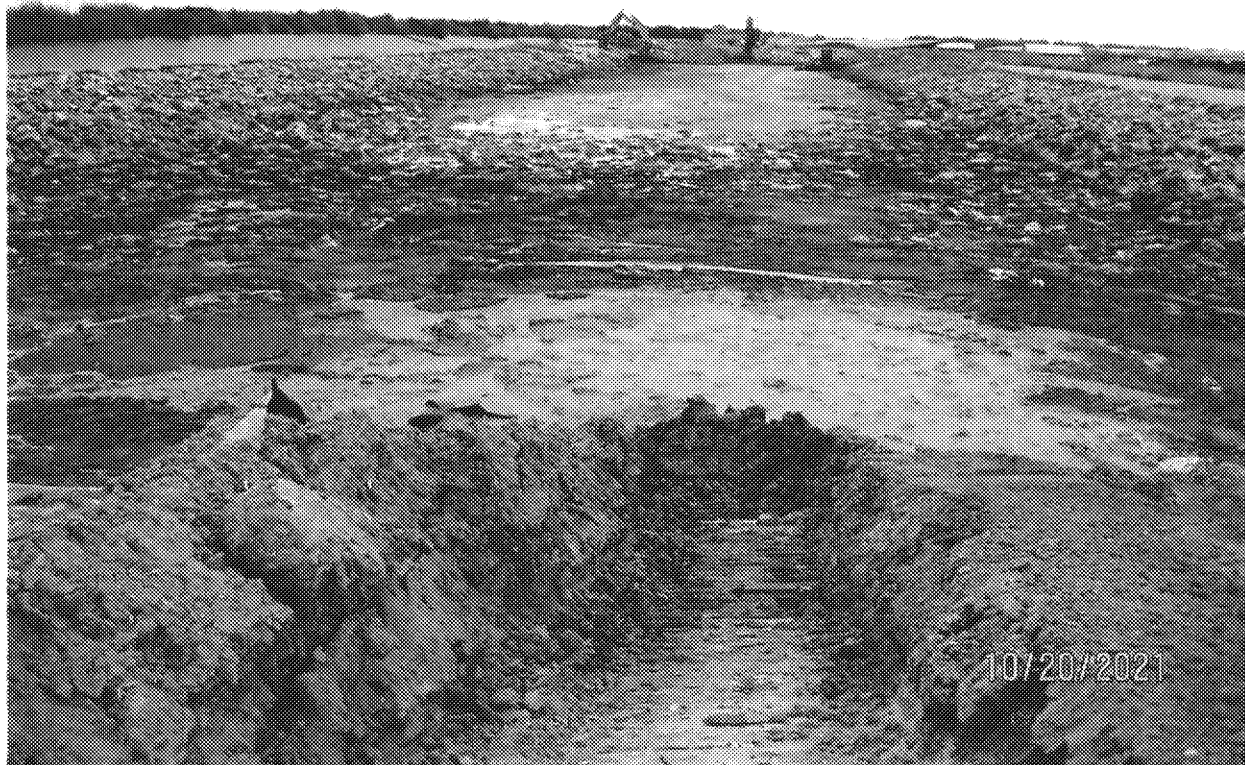
Photos: 12

Location: Emergency lagoon

Description: The photo shows the progress made in clearing out the emergency lagoon to repair the liner. Clean Harbors is using power pellets to absorb moisture which is then transferred to the wetcake storage area.

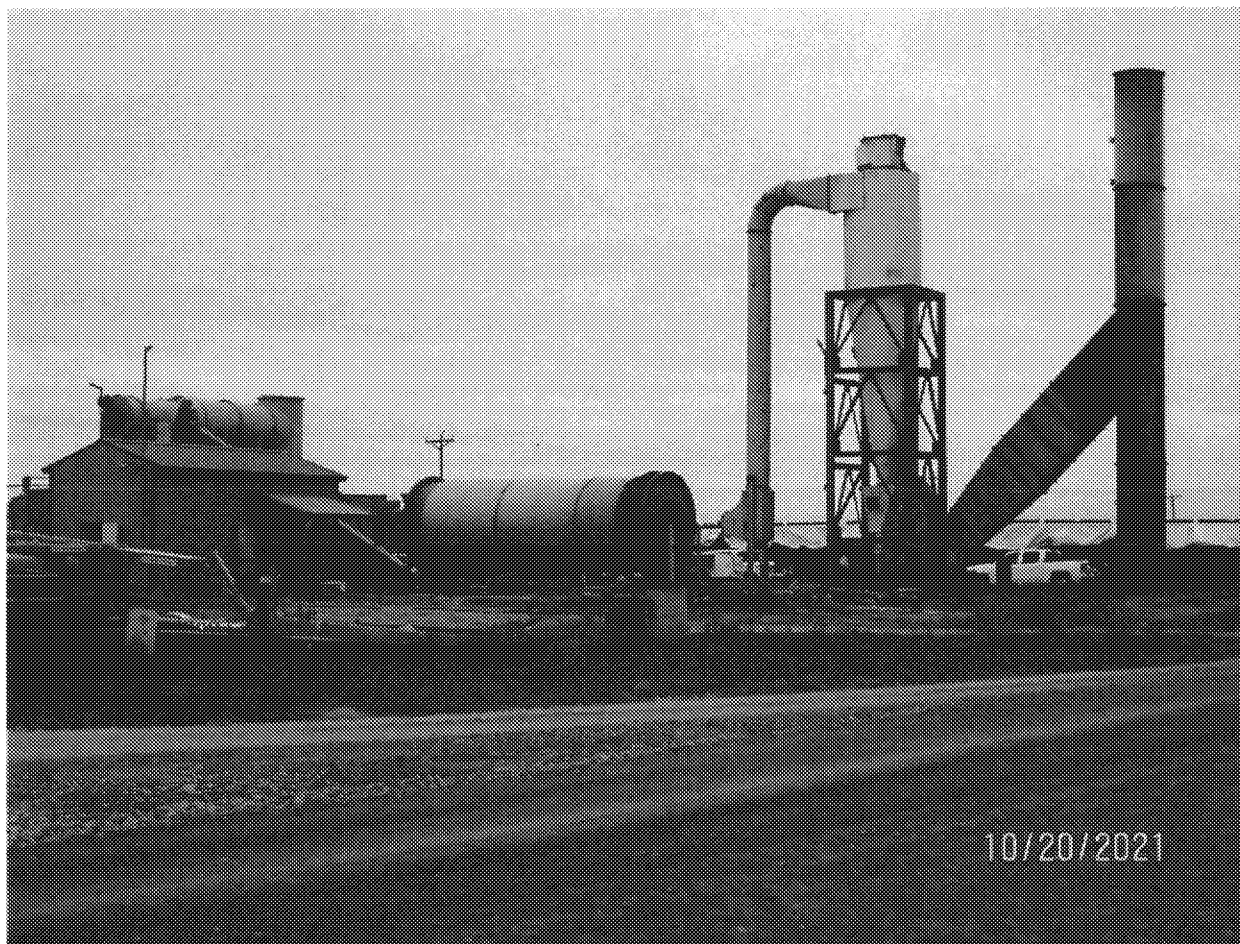
Photos: 13

Location: Biochar unit

Description: The photo shows the remaining components of the Biochar unit. It is currently being dismantled to be removed from the site. The silt fence surrounding the Biochar unit has been taken down during this process.

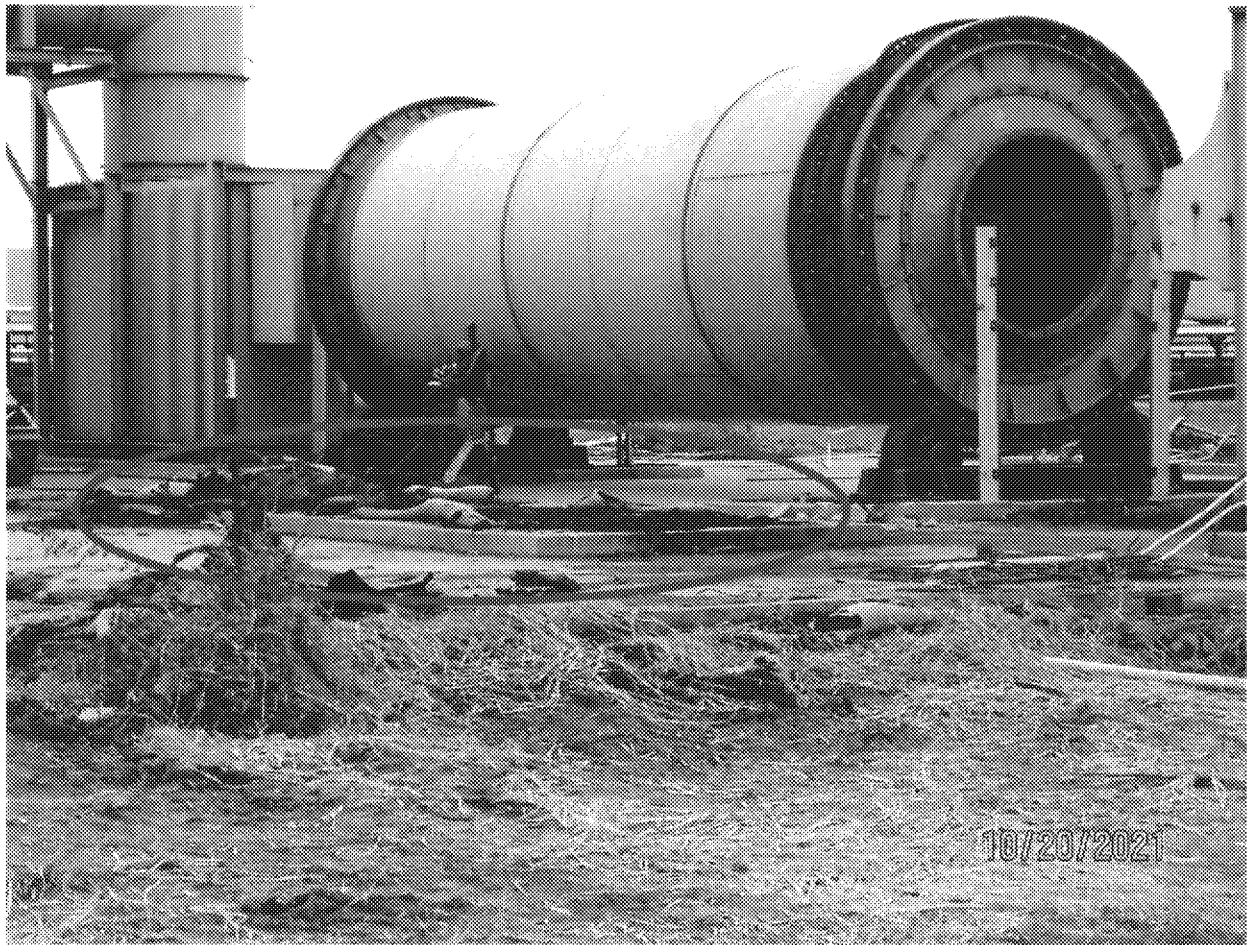
Photos: 14

Location: Biochar Unit

Description: The photo shows biochar on the pavement of the biochar unit. The equipment removal team has been driving equipment through the area and the containment fence has been taken down for the removal process.

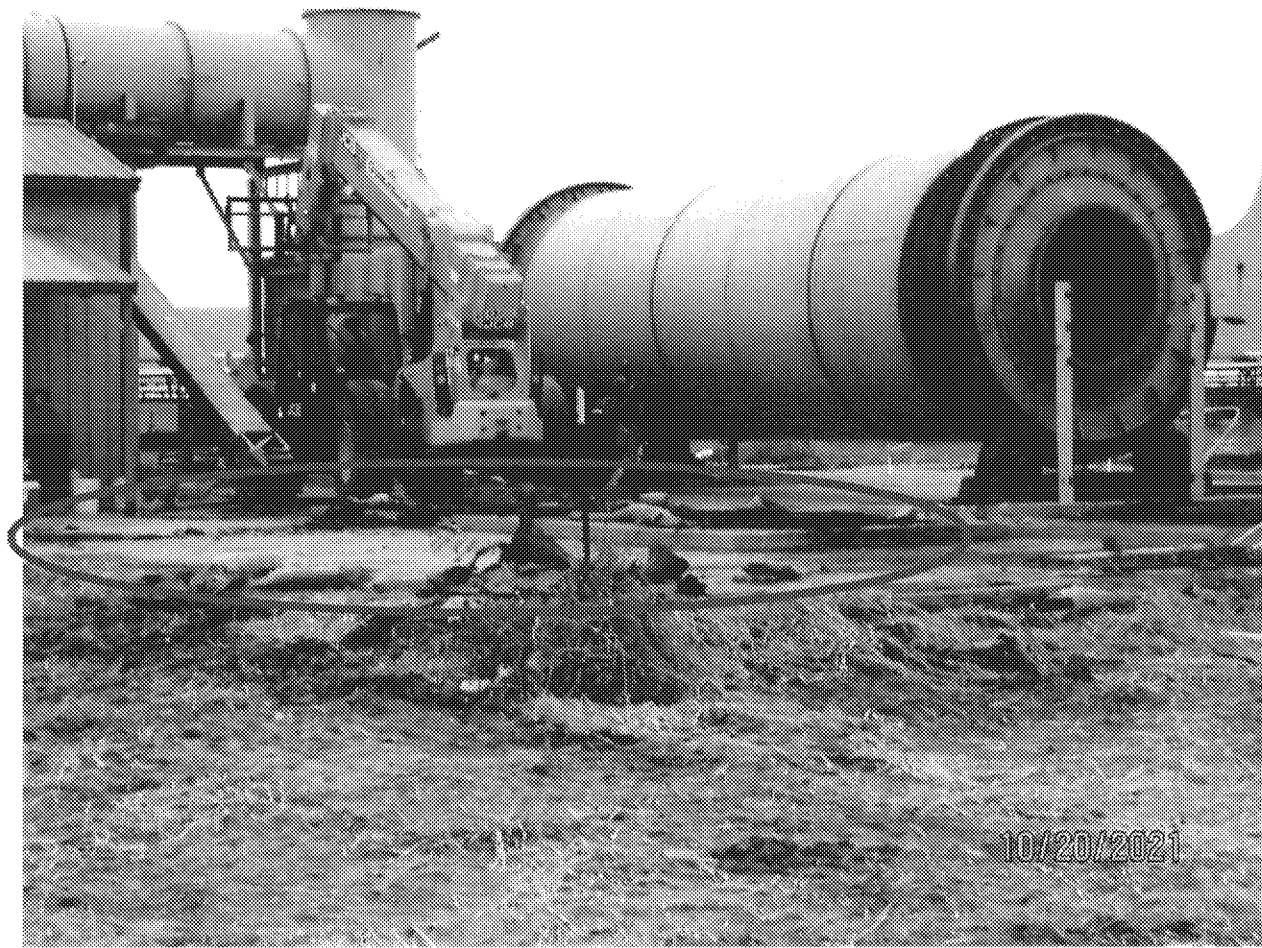
Photos: 15

Location: Biochar Unit

Description: The photo shows a crew removing components of the biochar unit. The containment fence has been taken down and the removal crew is driving through biochar on the ground.

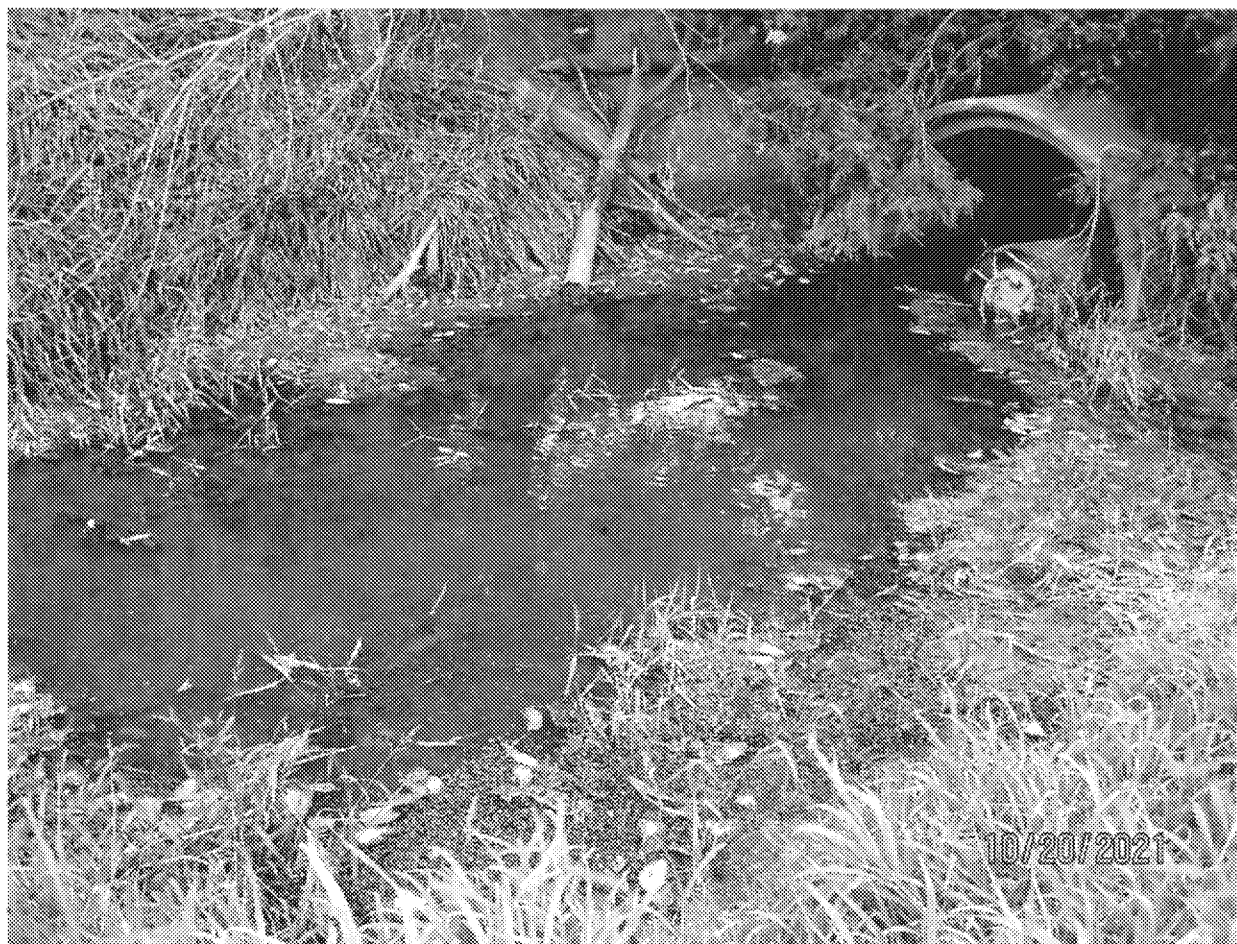
Photos: 16

Location: Culvert A

Description: The photo shows Culvert A near the former east wetcake storage area. The water in the culvert appeared very cloudy. The culvert still has an inflatable plug installed by Clean Harbors in the event of a discharge from the AltEn facility.
